**CULTURAL LANDSCAPE REPORT  
NORTH BRIDGE UNIT  
MINUTE MAN NATIONAL HISTORICAL PARK**

**SITE HISTORY, EXISTING CONDITIONS,  
ANALYSIS & EVALUATION, TREATMENT RECOMMENDATIONS**

**CONCORD  
MASSACHUSETTS**

January 2004

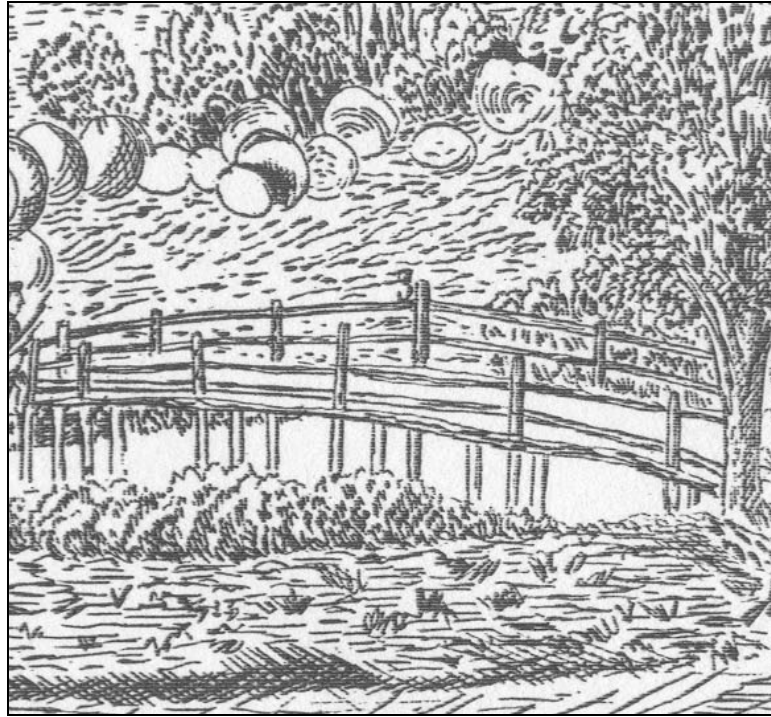
**Figure 7. Detail of the North Bridge, as depicted in the Doolittle Print, Plate III, *The Engagement at the North Bridge in Concord*, c. 1775.**

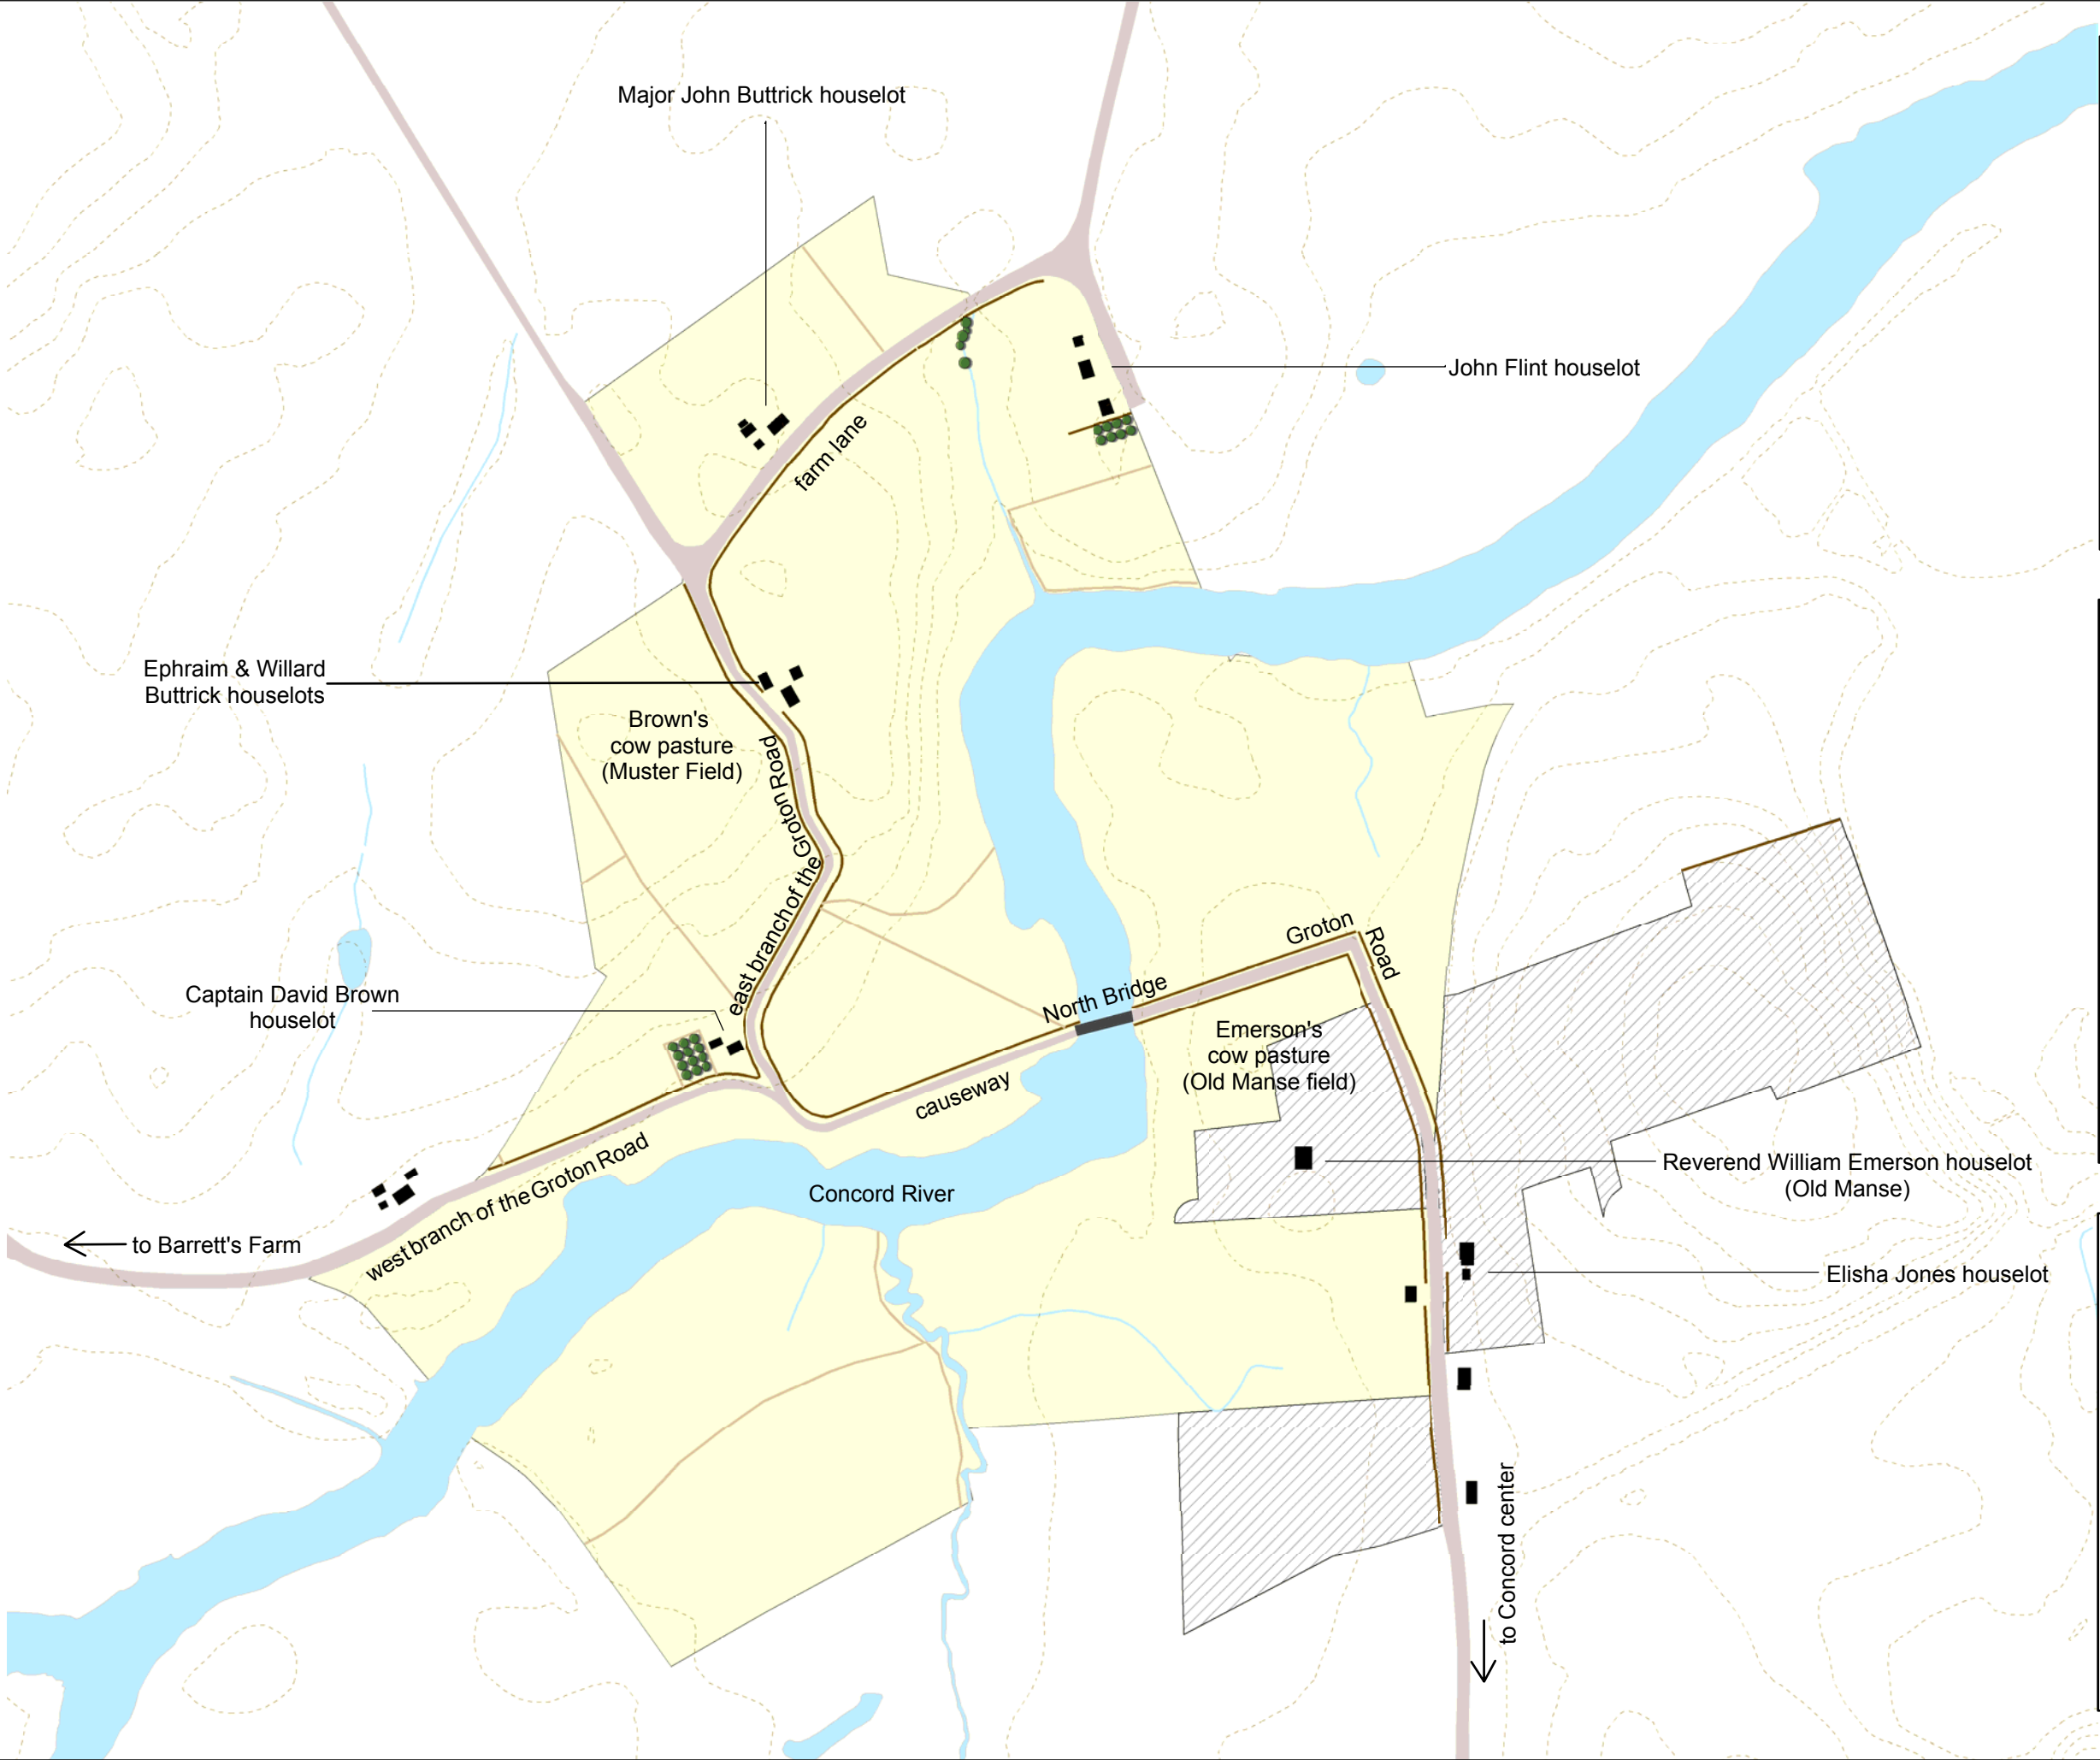
Figure 8

1775 Period Plan

through the area and crossing at the North Bridge, were the Concord River (Musketequid River) and Groton Road. A large portion of the land bordering the eastern side of the river was a wet meadow (Figure 8).

Five houselots stood west of the North Bridge on top of the ridgeline overlooking the river, along both branches of the Groton Road (Figure 8). The Flint and Brown homes were quite old at the time of the battle, both believed to have been constructed c. 1635. Major John Buttrick lived in a house his father, Jonathan Buttrick, had built for his parents c. 1710 to 1717. It replaced an original house built by his great grandfather William Buttrick that dated to Concord's early settlement. John Buttrick's brother Ephraim lived in the house built by John Heald, c. 1635. His other brother Willard lived in a new house constructed c. 1771-1775 on land deeded to him by Ephraim. Two houselots stood along the road east of the North Bridge (present-day Monument Street). Reverend William Emerson lived on the original Blood houselot in a house built c. 1769-1770, today known as the Old Manse. Elisha Jones lived across the road in a house that may have included at its core the house built by John Smedley before 1640.<sup>51</sup>

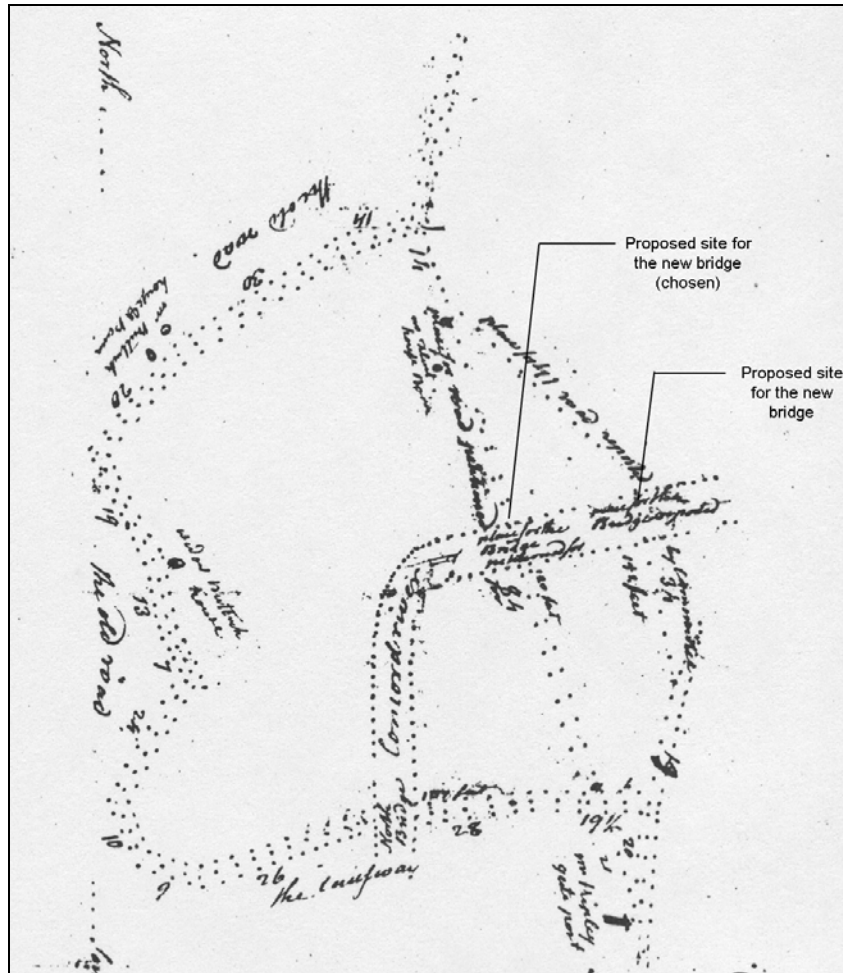
Figure 11. Map identifying two proposed locations for the bridge (Flint's Bridge) that would replace the North Bridge, c. 1792. The map also depicts the Concord River, the North Bridge, the causeway, and the east branch of the Groton Road, as well as the location of Mr. Ripley's (Old Manse) gate post, Widow Buttrick's house, Mr. Buttrick's house and barn, and Mr. Flint's house. (photographic negative #64-31, MIMA Library, Location of original map is unknown.)

New and improved roads, along with larger wagons, helped farmers transport agricultural products and timber to the urban market. Significant roadway and bridge improvements occurred within the present-day North Bridge Unit during the late 1700s. In 1788, the town replaced the North Bridge that stood during the battle at the North Bridge. Among the men paid for constructing the new bridge were Captain David Brown, Lieutenant Elisha Jones, and Colonel John Buttrick, all present during the battle and landowners within the present-day North Bridge Unit.<sup>57</sup> Three years later, neighboring landowners reiterated the 1748 request (see p. 18) to remove the North Bridge and to construct a new bridge near the home of John Flint. This time the town granted the request. In c. 1793, Concord constructed a new bridge, known as Flint's Bridge, downstream from the North Bridge (Figure 11).<sup>58</sup>

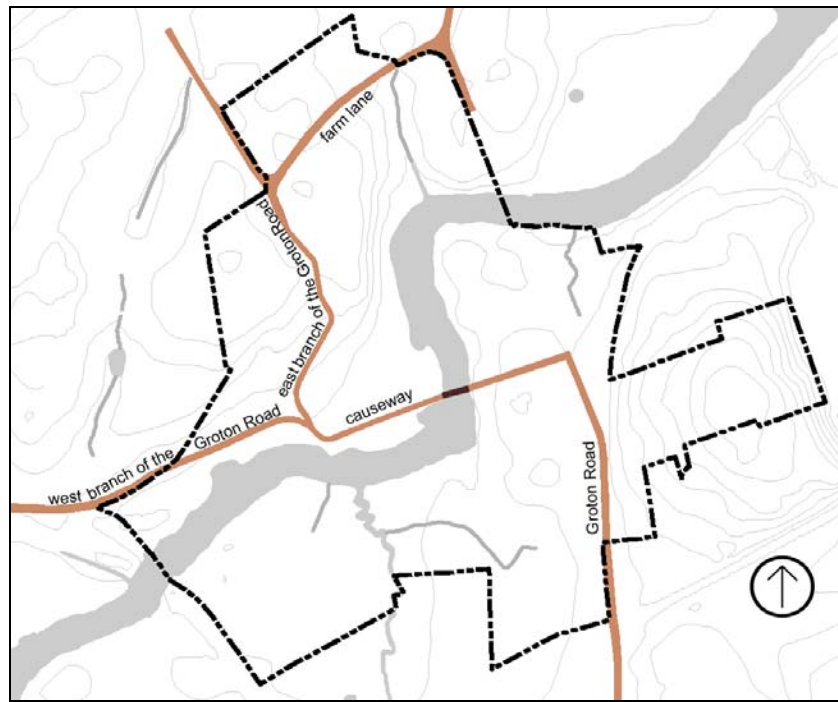
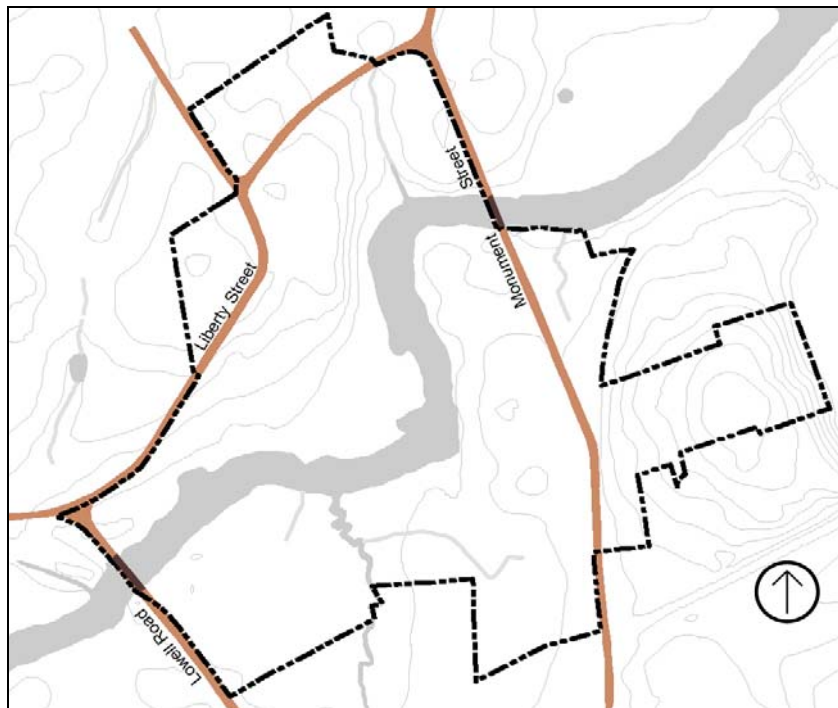
Figure 12. Road and Bridge Improvements, 1792-1793. (OCLP)

Bridge Unit.<sup>59</sup> Use of the North Bridge and the portion of the Groton Road passing over it were abandoned (Figure 12). Land within the abandoned roadway east of the bridge reverted into private ownership and was incorporated into adjacent fields and pastures.<sup>60</sup> In 1793, the town authorized Lieutenant Elisha Jones to remove the North Bridge and to allow landowners on the western side of the river to reroute the abandoned section of the road, at their own expense. The altered road alignment coincides with present-day Liberty Street.<sup>61</sup>

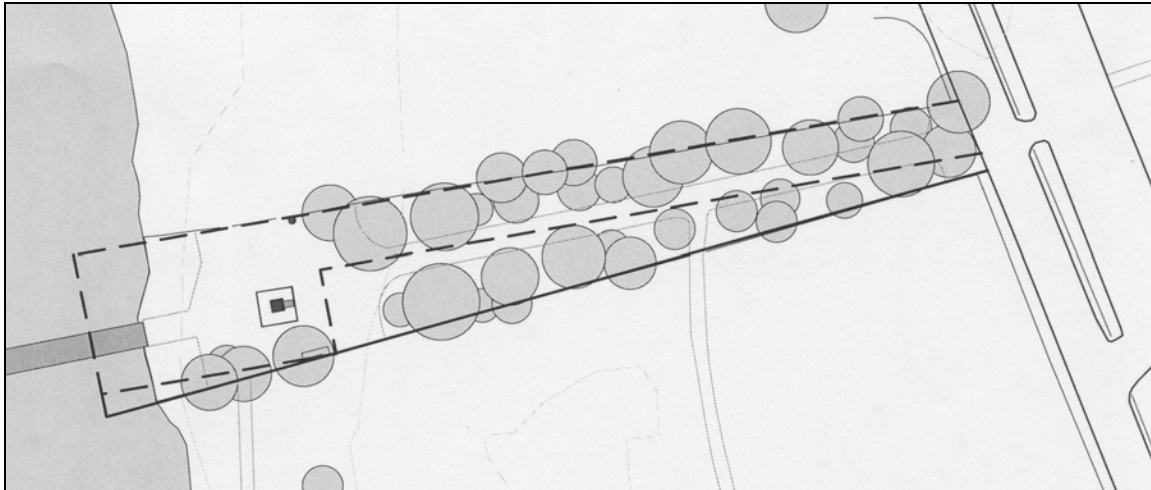
----- Boundary of land donated to Concord in 1835  
 \_\_\_\_\_ Boundary of land extension granted to Concord in 1836.

**Figure 13. Map of land donated by Ezra Ripley to Concord for the 1836 Monument. Based on Ezra Ripley to the Town of Concord, 390:427 and Ezra Ripley to the Inhabitants of Concord, 390:428. Historic property boundaries are drawn on Existing Conditions map (Figure 80). (OCLP)**

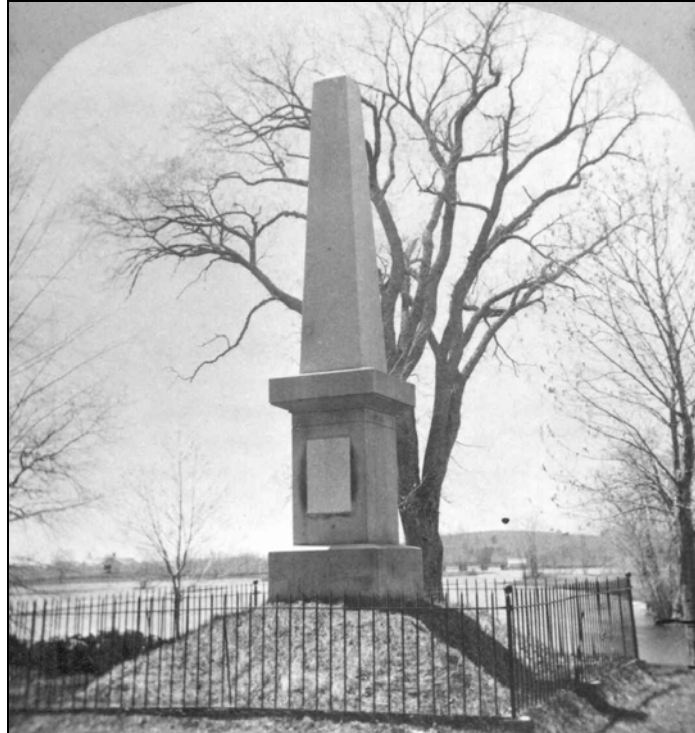
Figure 14. Stereoscopic view west of the 1836 Battle Monument. Note the Concord River in the background, the great elm behind the monument, and the iron fence enclosing the monument base. (Photograph Files, Concord Free Public Library)

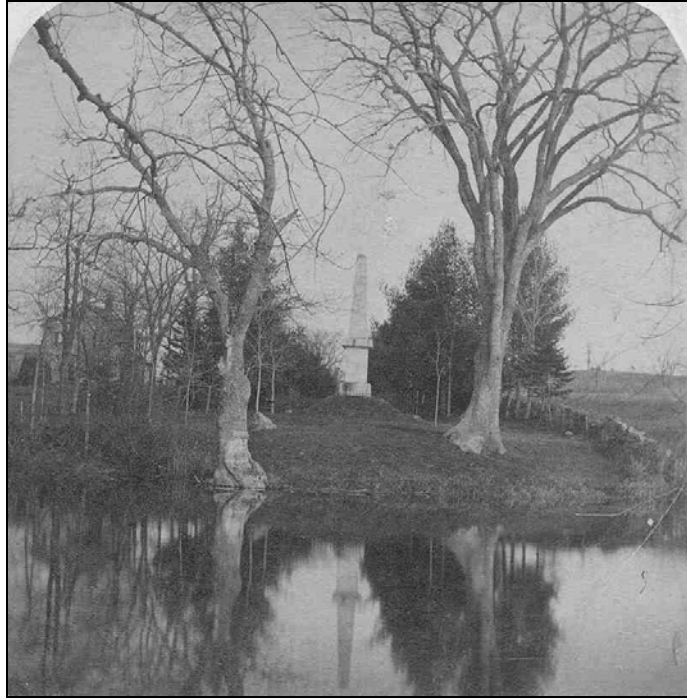
**Figure 16. Stereoscopic view east of the 1836 Battle Monument and alleé, 1858. Note the Concord River, the Simmons house (left, behind trees), the stone wall and the great elm (right). The obelisk sits on a small earthen berm. (Stereoscopic photograph, Lothrop Stereoscopic Collection, Box 10, MIMA Archives)**

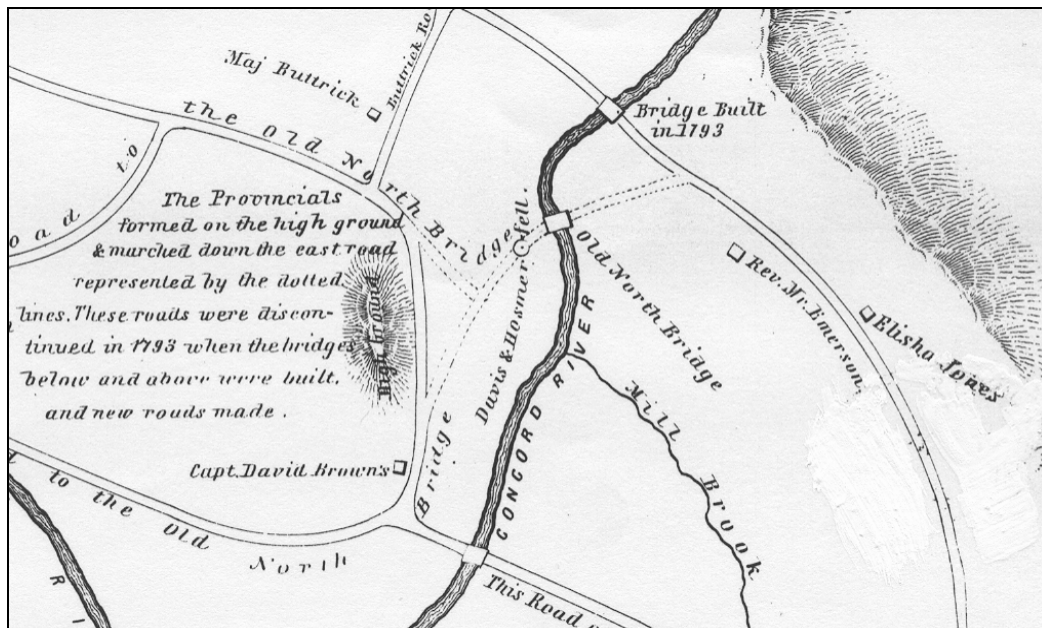
Figure 18. "Map of the Scene of the Concord Fight, in 1775," Domrell & Moore Printers, Boston, 1850. The map depicts the location where Davis and Hosmer fell along the discontinued section of Groton Road (dashed line) leading across the North Bridge. (Copy located at Concord Free Public Library)

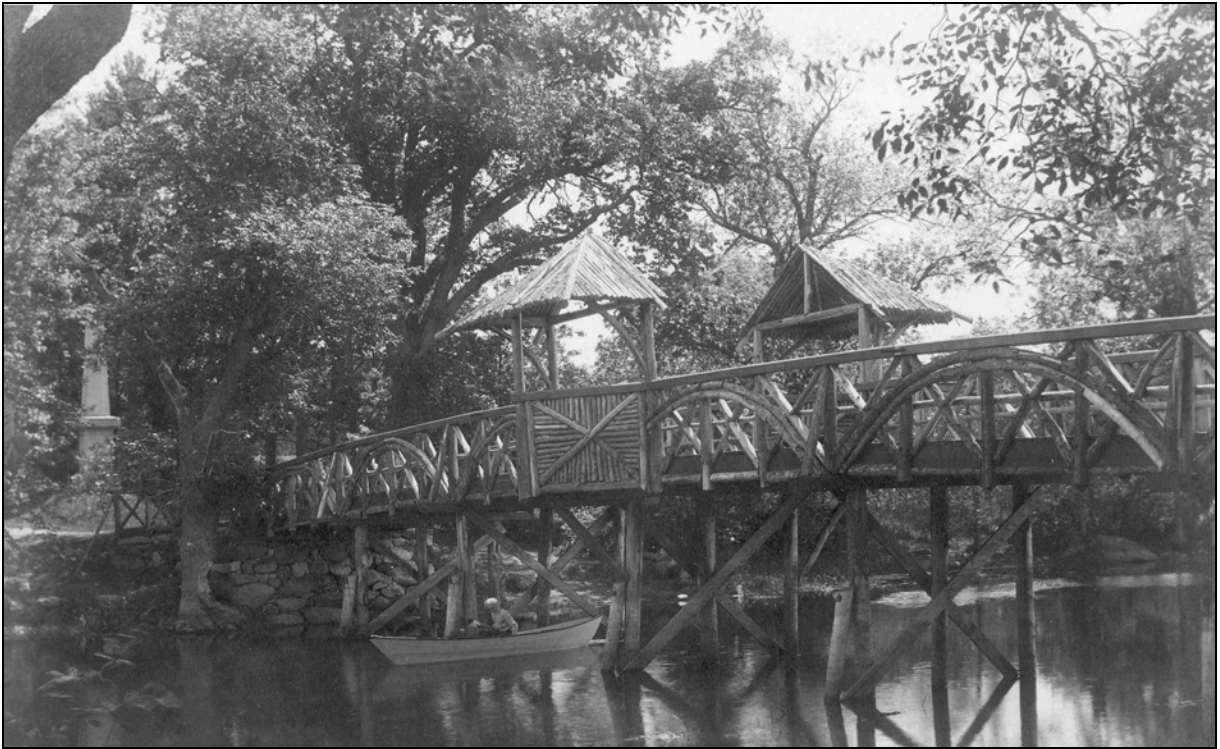
Figure 20. 1874 commemorative North Bridge, view southeast. Photograph by Alfred Hosmer, c. 1880-1888. Also visible is the 1836 Battle Monument. (MIMA Photographic Collection, Box 12, #34167, MIMA Archives)

The commemorative North Bridge, designed by Boston Architect William R. Emerson, was constructed during the summer and autumn of 1874. Although there was, at least initially, a desire to make the new bridge resemble the old North Bridge, Victorian taste ultimately prevailed. The ornately rustic 1874 commemorative North Bridge substituted “a paling of graceful pattern, made of cedars with the bark on” for the rough railings of the 1775 bridge. The bridge included two equally rustic half-arbors centered at the top of the bridge and projecting over the water “where pilgrims might sit and watch the quiet river brimming its meadows” (Figures 20-23).<sup>98</sup>

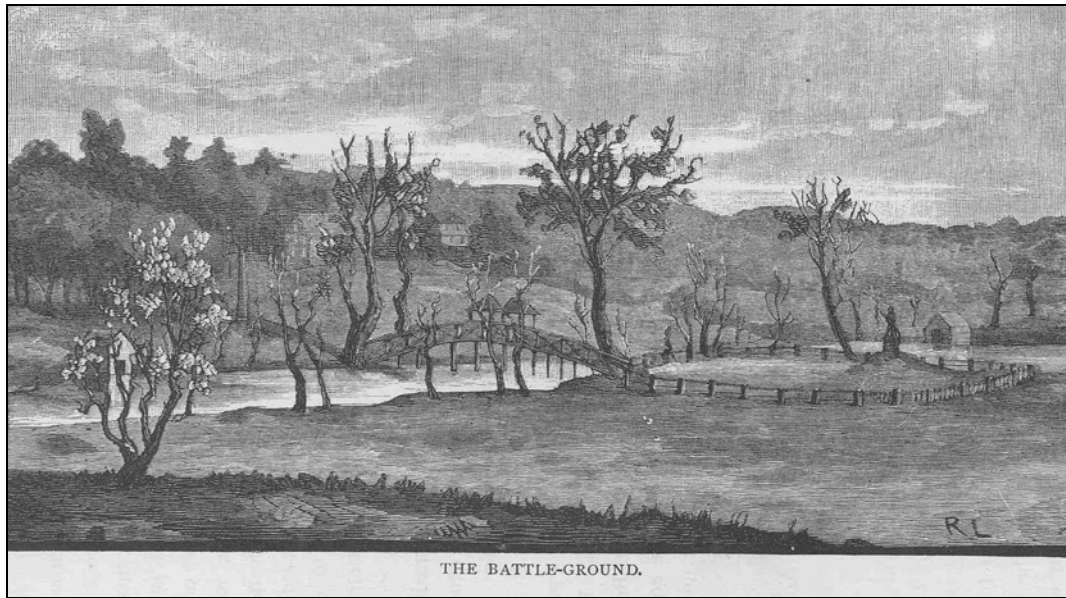
Figure 22. Engraving of the battleground depicting the 1836 Battle Monument (left), 1874 commemorative North Bridge, The Minute Man statue, and the repositioned iron fence (right) and wooden railing encircling the statue. Also depicted are the Old Manse (distance-center) and a boathouse (right), possibly the Old Manse boathouse. Illustration by Robert Lewis, 1880. (Engraving appeared in George B. Bartlett's *The Concord Guide Book*)

**Buttrick Boathouse:** The Buttrick Boathouse was located just north of the commemorative North Bridge, on the west side of the Concord River. It appears in historic photographs from the late 1800s. By 1900 the structure had been removed.<sup>111</sup> In 1892, William Brewster, the first president of the Massachusetts Audubon Society, noted in his journal he had supervised the moving of his boathouse “from the Manse to the Buttrick landing.”<sup>112</sup> The Buttrick Boathouse may have been the boathouse mentioned in his journal. If so, it may be depicted in its original location on a c. 1880's illustration, just south of the Old Manse Boathouse (see Figure 22).<sup>113</sup>

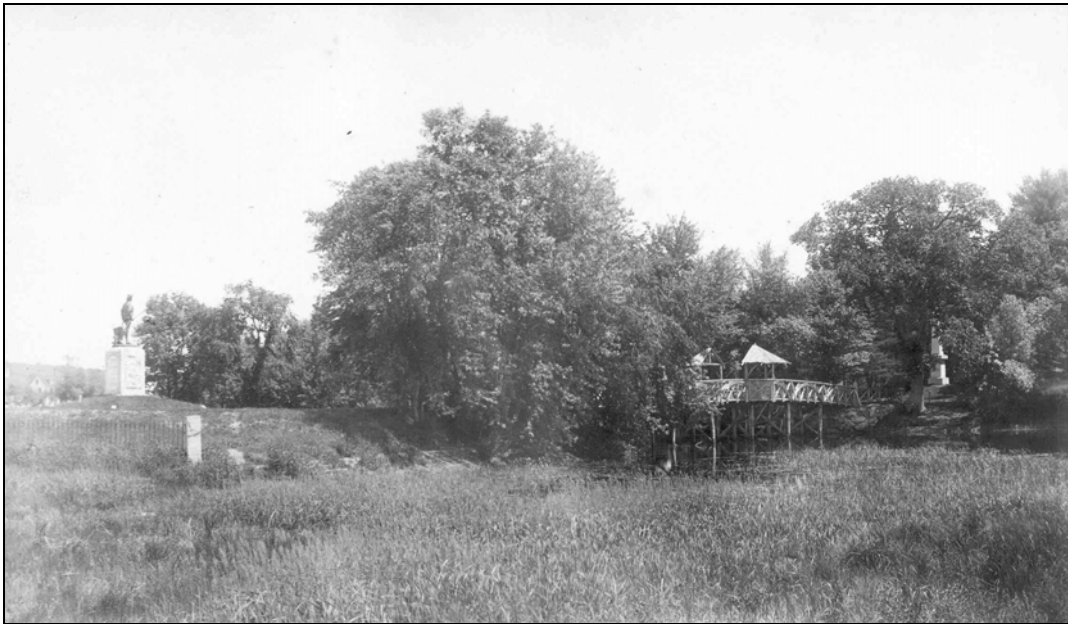
Figure 23. View northeast of The Minute Man statue (left), the 1874 commemorative North Bridge (center) and the 1836 Battle Monument (right). Photograph by Alfred Hosmer, c. 1880-1888. Concord River and wetland are in foreground. Visible in the photograph are the linear arrangement of the monuments and the commemorative North Bridge, and the iron fence surrounding the bermed Minute Man statue (note stone pillar). (MIMA Photographic Collection, Box 12, #34306, MIMA Archives)

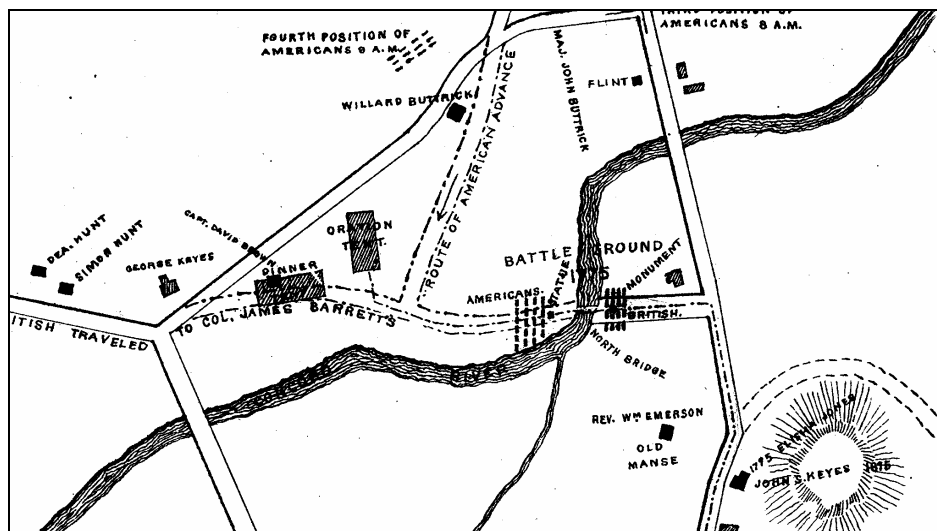
Figure 25. "Centennial Map of Concord" from surveys by H. W. Blaisdell in the souvenir book "American's First Centennial Celebration," 1875. The map depicts the locations of the centennial anniversary celebration oration and dinner Tents, on the site of Captain David Brown's houselot.

In preparation for the centennial anniversary celebration, Concord erected two large tents west of the 1874 commemorative North Bridge on the site of the Captain David Brown houseplot (Figures 25-27). The oration tent measured 200 feet by 85 feet, and the dinner tent 410 feet by 85 feet. The oration tent provided standing room for six thousand and the dinner tent seating for about forty-five hundred. Neither was large enough to accommodate the twenty thousand expected visitors or the fifty thousand that actually attended the centennial anniversary celebration. Most were unable to see or hear any part of the celebration other than the morning parade.<sup>101</sup>

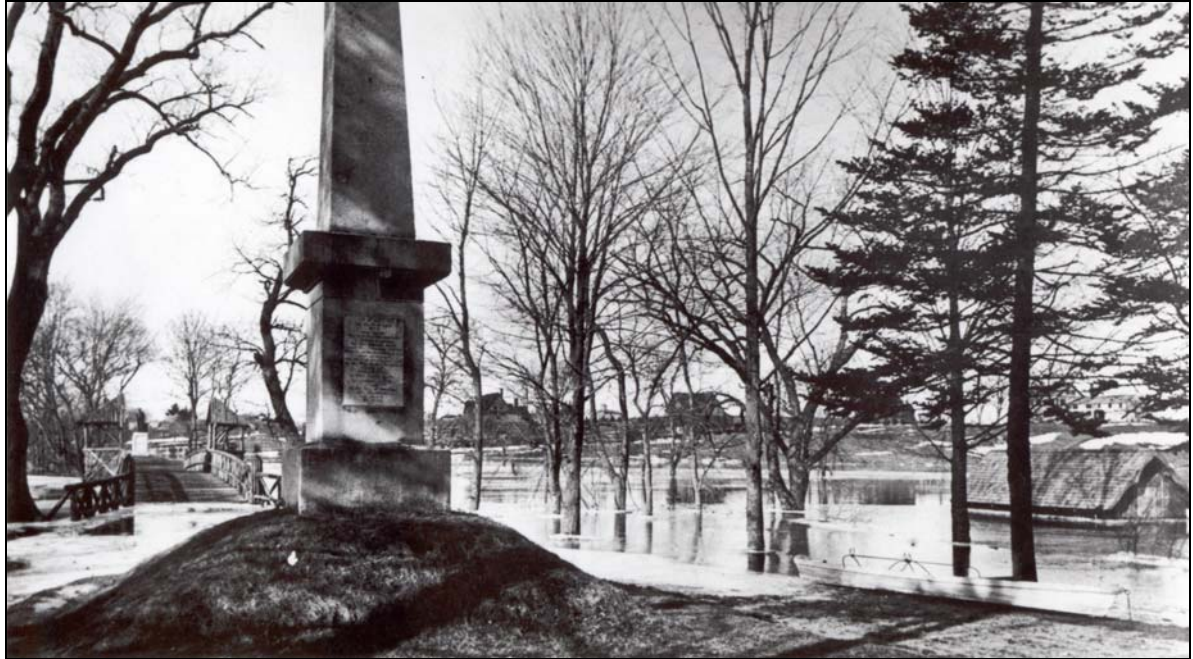
**Figure 37. Spring flooding at the 1874 commemorative North Bridge. Photograph by Alfred Monroe, c. 1875-1888. View west across the 1874 commemorative North Bridge, great elm in the foreground (left) and The Minute Man statue in the background. (Monroe Photographic Collection, IV.4, Concord Free Public Library)**

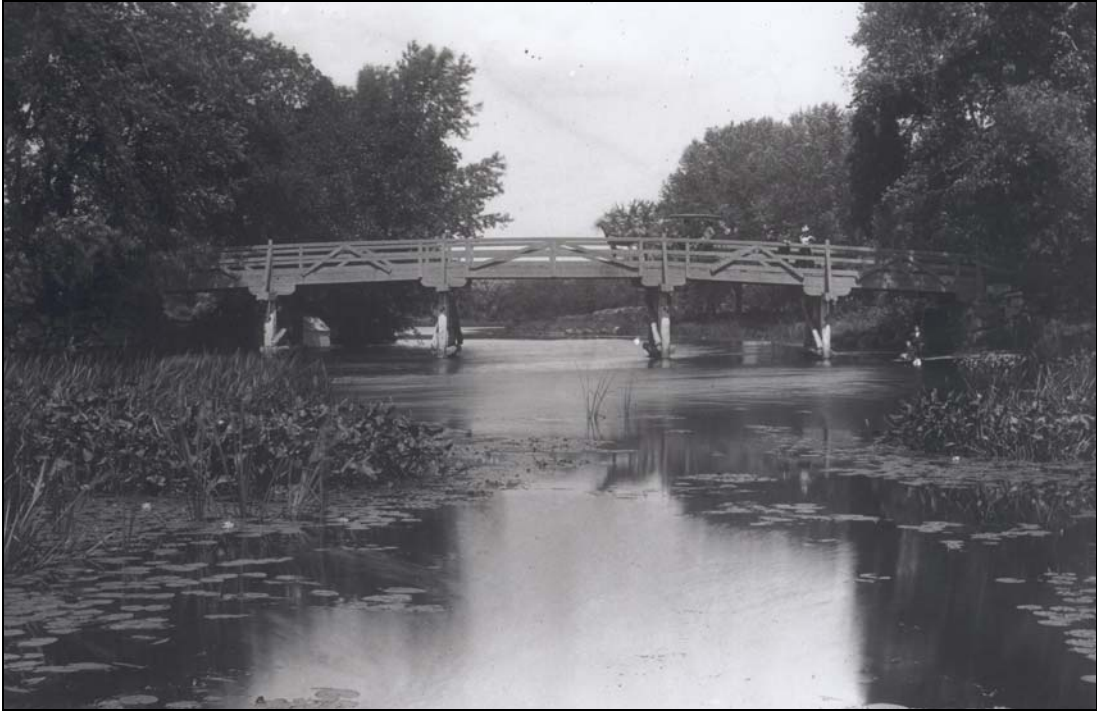
Figure 38. View north of the 1888 commemorative North Bridge. Photograph by Alfred Monroe, c. 1888-1902. (Monroe Photographic Collection, IV.3, Concord Free Public Library)

Two new commemorative bridges were constructed during this period, one in 1888 and the other in 1909. High spring water levels exerted pressure on the bridges, weakening their hold (Figure 37). The 1888 commemorative North Bridge replaced the 1874 commemorative North Bridge, which was carried away by the 1888 spring freshnet. In an attempt to strengthen the new bridge, the delicate features of the rustic 1874 commemorative North Bridge were replaced with heavy oak piles, posts, railings, and diagonal props (Figure 38). Despite its sturdier construction, the second bridge fell during the spring flood of 1909. Later that year, under the direction of the Massachusetts Department of Public Works, the town built the third commemorative bridge. The bridge was constructed of concrete in a determined effort to extend its life span. For the first time, the design of the bridge closely followed that of the historic North Bridge as depicted in the Doolittle Print (Figure 39). Although design of the 1909 commemorative North Bridge approached historical accuracy and its structure withstood the devastating effects of flooding for over forty years, many disliked the bridge because of its concrete construction.<sup>120</sup>

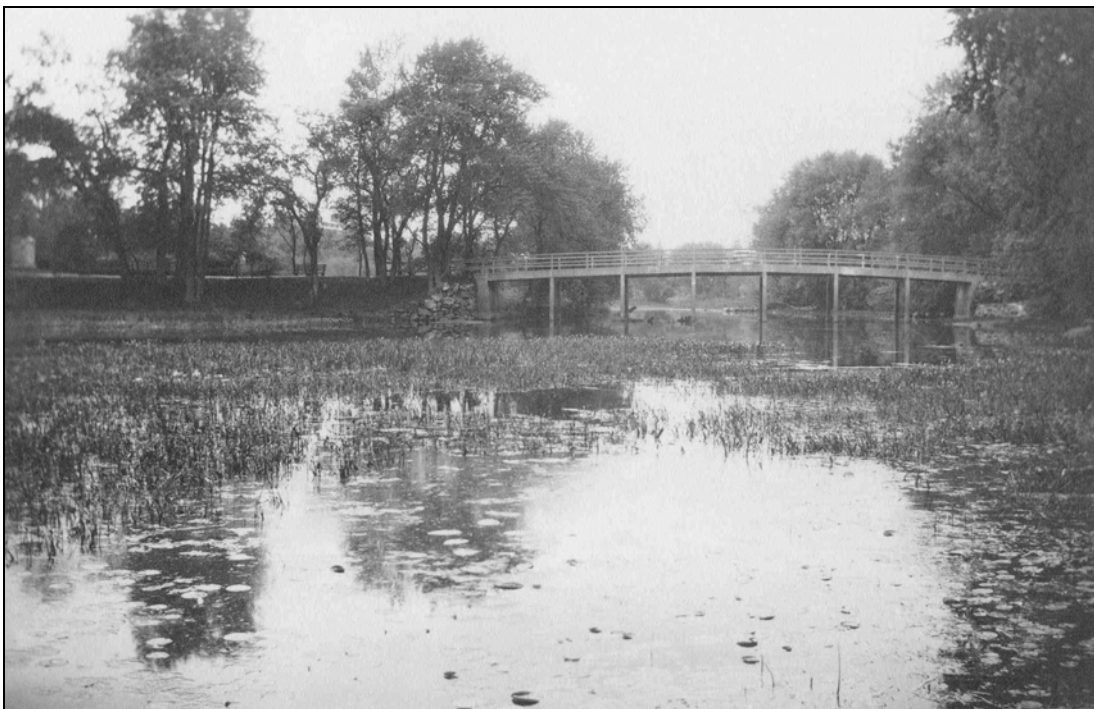
Figure 39. View north of the 1909 commemorative North Bridge. Photograph by James H. Tolman, c. 1925. (MIMA Photographic Collection, Box 12, #34289, MIMA Archives)

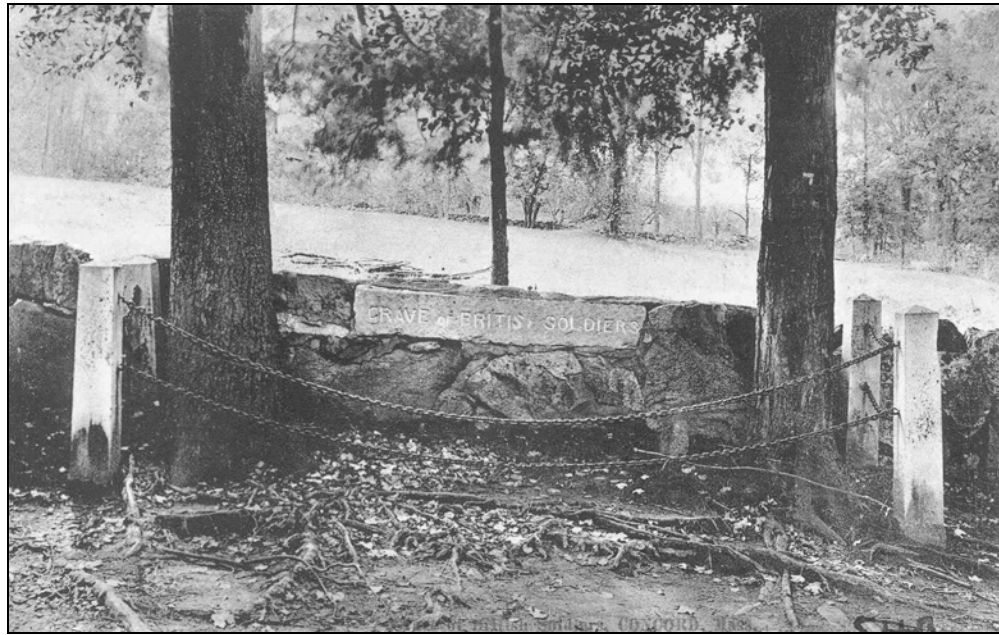
**Figure 40. Postcard of the Grave of the British Soldiers, pre-1910. Note the granite post and chain fence, the stone marker, and the two trees flanking the graves. (MIMA Postcard Collection, Box 1, MIMA Archives)**

In 1877, Concord placed a granite post and chain fence around the Grave of the British Soldiers at the expense of Herbert Radclyff, an English-born Bostonian. The gravesite was further enhanced in 1910 when a slate slab engraved with the last quatrain of James Russell Lowell's 1849 poem "Lines" was placed in the stone wall above the graves:

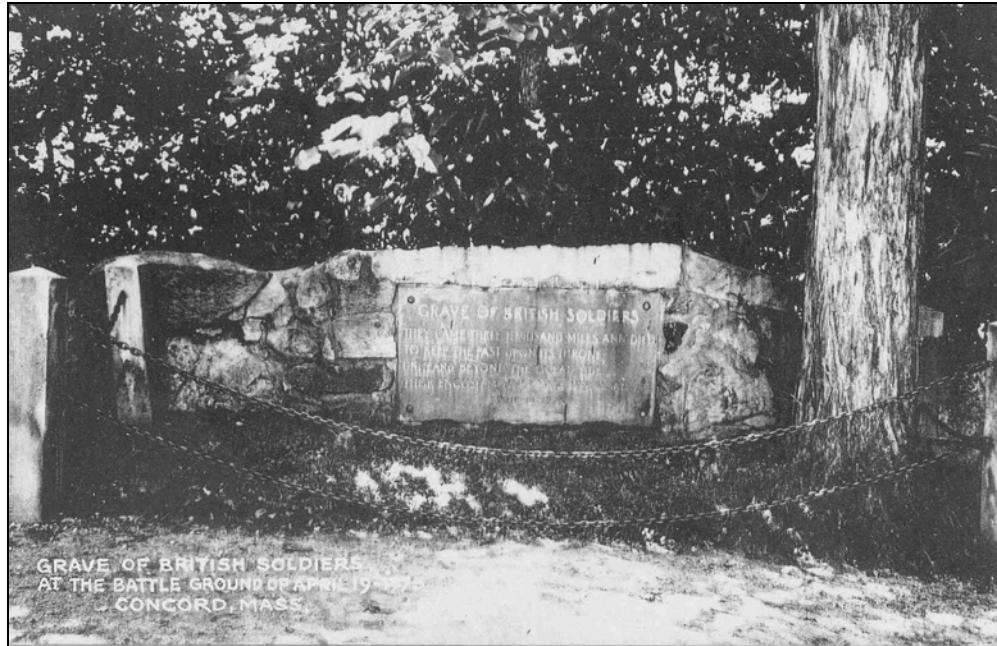
**Figure 41. Postcard of the Grave of the British Soldiers, post-1910. Note the new inscribed slate tablet, the granite post and chain fence, and the absence of the tree, which previously flanked the left side of the monument. (MIMA Postcard Collection, Box 1, MIMA Archives)**

Lowell's poem was suggested by a visit to the gravesite. As mentioned earlier, Lowell visited the grave with Nathaniel Hawthorne, before the publication of Hawthorne's book *Mosses of the Old Manse* (1846). Peter Brooks, a direct descendent of an original Concord settler, donated the funds to erect the marker. (Figures 40-41)<sup>122</sup>

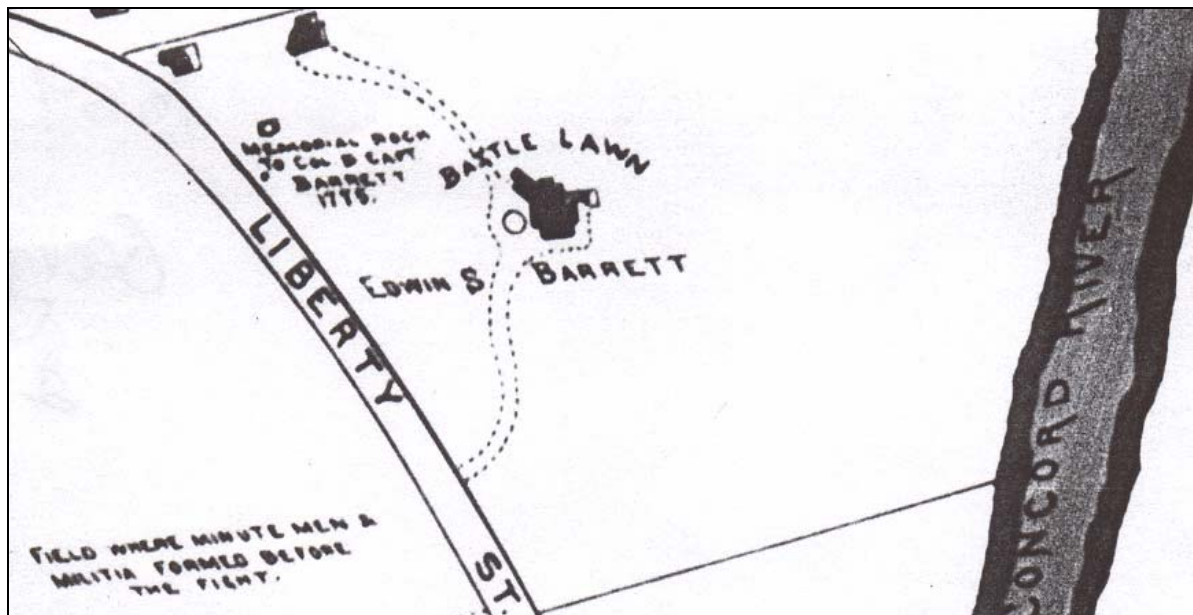
Figure 50. "Part of Concord," George H. Walker & Co., 1889. Map depicts the Battle Lawn mansion, driveway, barn (end of driveway), gardener's cottage (left of barn), and stone marker (labeled). Also identified on the map is the portion of the Muster Field lying north of Liberty Street. The construction of Liberty Street in 1793 bisected the Muster Field. North is to the left on the map.

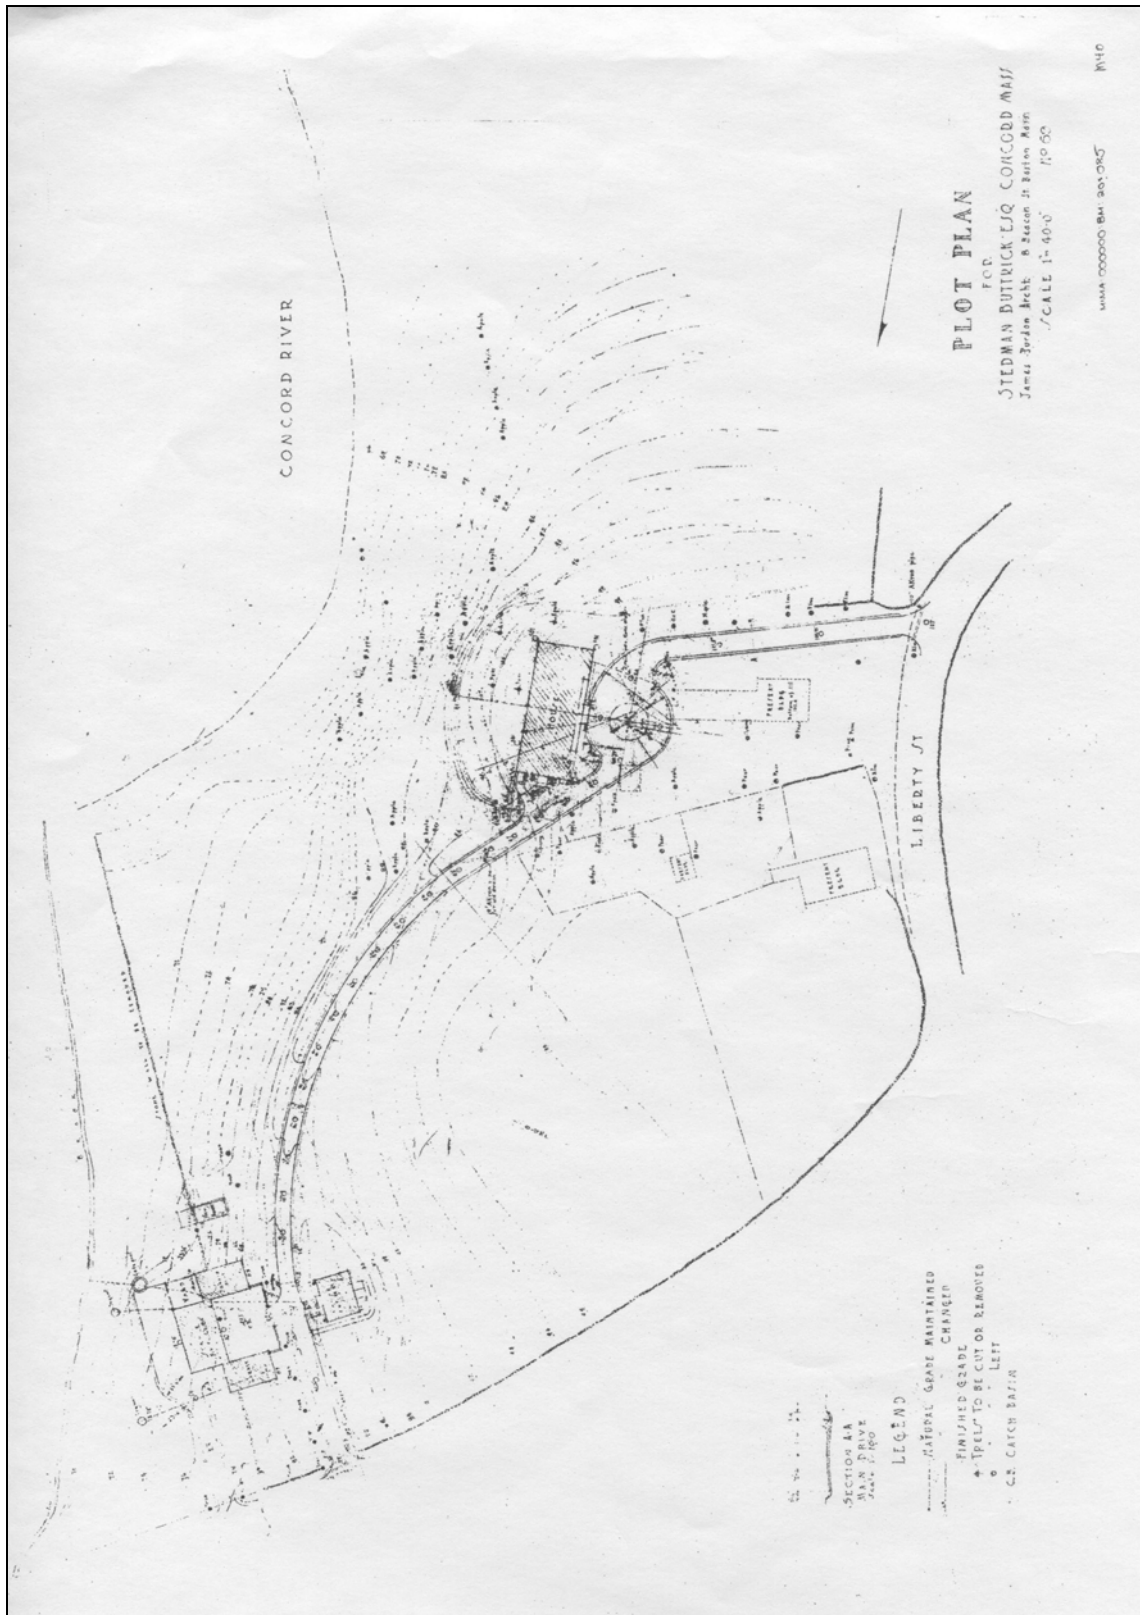
Figure 55. "Plot Plan for Stedman Buttrick, Esq., Concord Mass," c. 1911. (NPS-19, Box 3, Roll 8, National Archives and Records Administration, Waltham, MA)

Soon after acquiring the Buttrick farm, Buttrick hired Boston Architect James Purdon to design a mansion and to layout the estate. Purdon's layout included the location of proposed buildings (Buttrick mansion, caretaker's house, and carriage house) an entrance drive, and a service drive. The plan required removal of a stone wall, farm buildings, and a portion of an extensive orchard growing along the top and on the western slope of Buttrick Hill. Several areas required grading to accommodate proposed buildings (Figure 55).

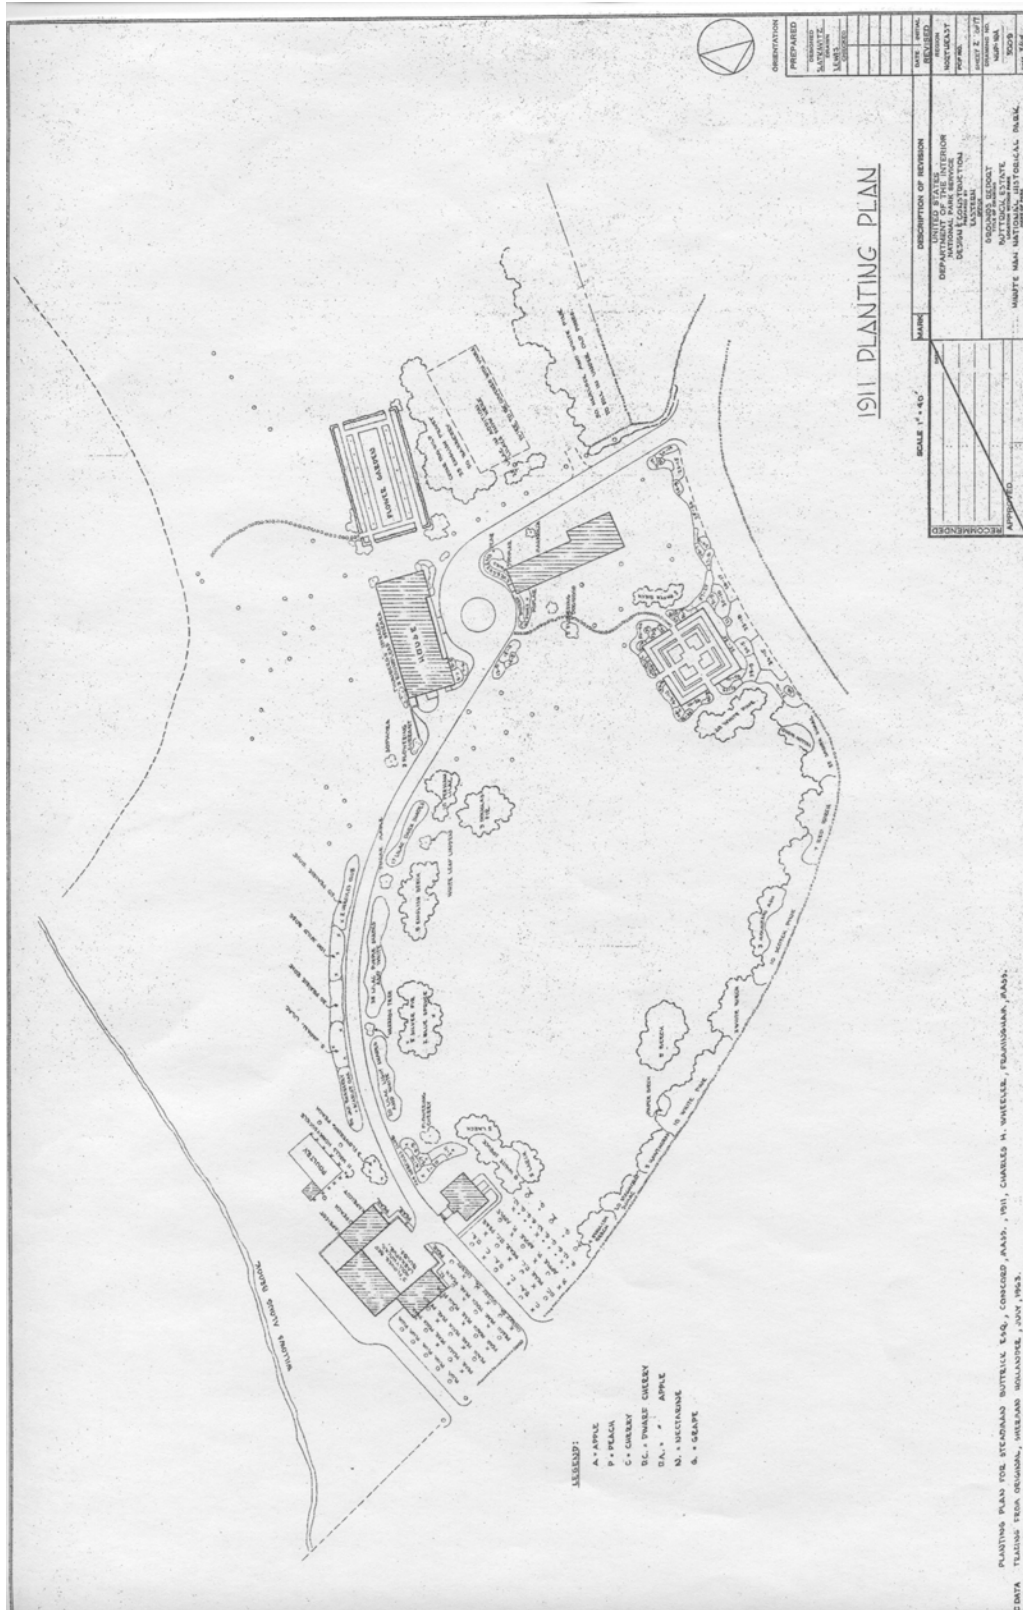
Figure 56. NPS tracing of “Planting Plan for Stedman Buttrick, Esq., Concord, Mass.,” 1911, tracing 1964. (Original located in MIMA Archives, MIMA 24472)

(Stedman Buttrick I house) was moved to the “easterly side of Monument Street opposite the end of Liberty Street.”<sup>145</sup> The caretaker’s cottage and the carriage house were built partially on the property purchased from Mary E. Davis in 1910 (western one-half of Flint field). During the same year, Buttrick hired Charles H. Wheeler of Framingham, Massachusetts to create a planting plan for his estate. Wheeler’s plan included a rectangular flower garden south of the proposed mansion (upper garden), an orchard adjacent to the proposed caretaker’s cottage and carriage house, and a rectangular plot southwest of the mansion identified on later plans as a tennis court.<sup>146</sup> The listed features are known to have been constructed. It is not known if other plans appearing on Wheeler’s drawing were ever implemented (Figure 56).
